HISTORIC STRUCTURE REPORT

COIT TOWER SAN FRANCISCO, CALIFORNIA

Dan Peterson, AIA, Historical Architect
Geraldine Peterson, Designer - Preservation Specialist
Ann-Marie Meenahan, Designer - Preservation Specialist
Interactive Resources, Inc.
Architects and Engineers
117 Park Place
Point Richmond, CA 94801
415-236-7435
Fax: 415-232-5325

April 1989

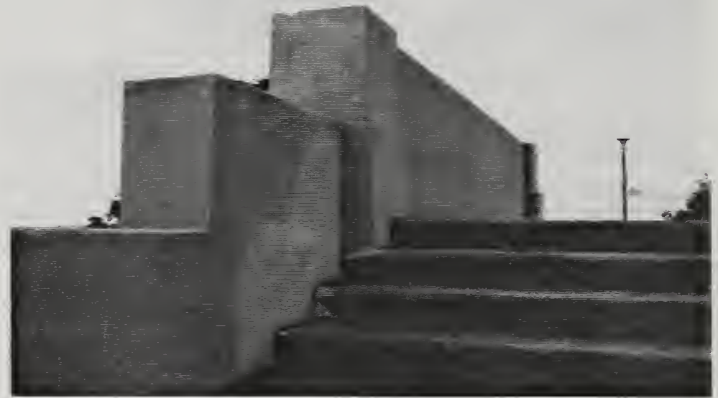
E-4. Graffiti and rain on the front retaining wall. (48-4)

Preservation Treatment: The terrace retaining walls and planters should be periodically maintained only when necessary by removing the stains with the gentlest methods possible. The Historical Architect recommends the use of *Sure Klean* "Defacer Eraser" or "Graffiti Control"

products by the company ProSoCo, Inc. in Kansas City, Kansas. Laboratory tests should be performed on sample finishes with the Graffiti Control material to assure that the vapor transmission characteristics remain the same. (There have been previous tests to determine the vapor transmission of the original material and the new texture applied.) The Bureau of Architecture has a dash gun for future maintenance of the dash coat. This dash gun must be used sparingly, and only after unsuccessful attempts with chemical cleaners. There are a few cracks that should be periodically monitored. Repair may be necessary only in extreme cases utilizing the same methodology as outlined in the IRI report. The shifting of the retaining walls at the expansion joints should be monitored. If there is continuously no change in the amount of wall movement, the retaining wall can remain. It is likely that the wall settled into place shortly after construction due to the weight of the building. Corrective measures should be taken only if the wall is moving at a continual rate. Then the walkway in front of the wall can be removed, the fill changed to a lighter, more porous fill, the retaining wall moved back into place, then reconstruct the walkway, duplicating the original walkway. Tile scuppers should replace the weep holes to enable the water runoff to fall in the plants, not along the surface of the planter. The security panels covered with dash coating should be removed and replaced with a more sensitive design.

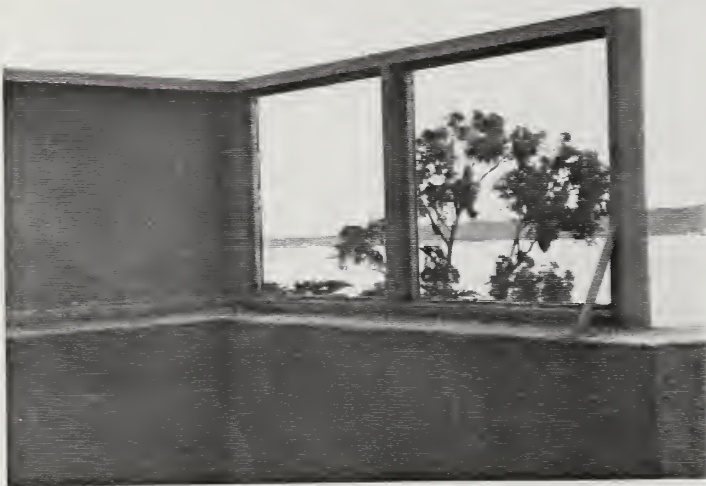
E-7. Aluminum panel with dash coating. (61-22)

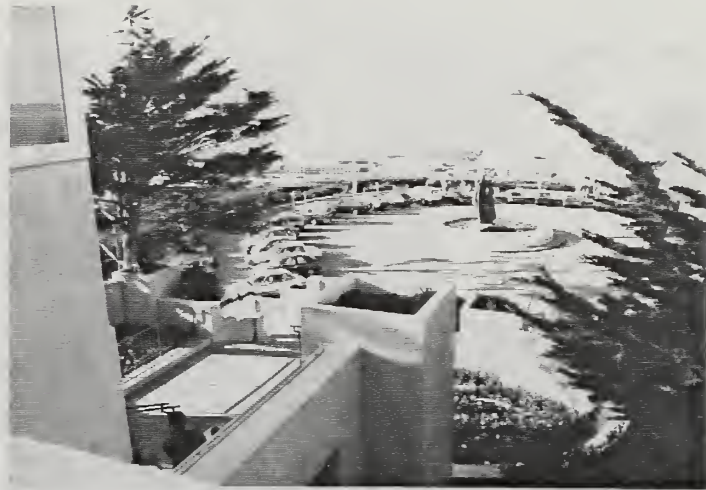
E-9. Marble planter in
center of parking lot.
(39-21A)

Preservation Treatment: The marble should be cleaned by a professional stone conservator. See pp. 13 - 15, Sec. of Interior Guidelines, Preservation Brief #1, and Preservation League, Technical Series/No. 5.

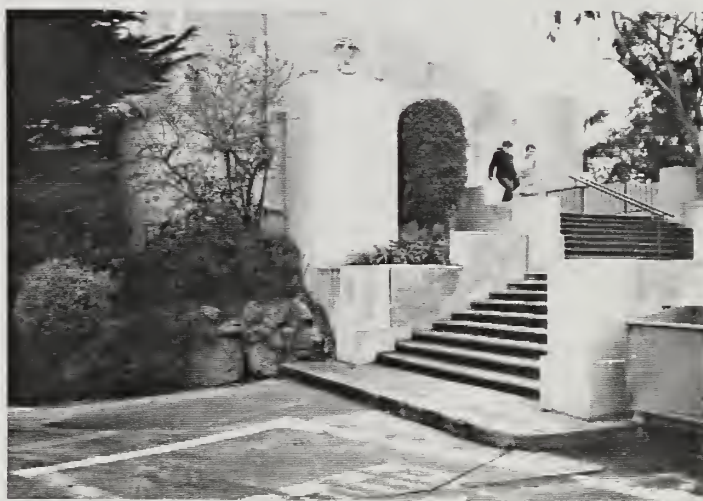
Description and Condition: Parts of the entrance porch and steps were located on Telegraph Hill before Coit Tower was constructed. They were the steps to an observatory, a wooden structure that had burned down in the late 1800's. Therefore the porch and steps have great historical significance and should be preserved. The front porch has been greatly altered with the addition of the revolving door. Concrete steps replaced brick steps, and consumed a portion of the pattern on the concrete porch. The concrete porches, steps, and paved walkways around the tower and parking lot appear to be worn and cracked in places with some vegetation growing in the cracks. The asphalt walkway on the south side of the tower, leading to the stone stairway, appears to be in good condition. The stairway on the west side of the tower, leading to the road, has field stone steps and retaining walls with metal pipe railing. The field stones appear to be in excellent condition and may not require maintenance. Photo nos.: E-11 thru E-15

E-12. Detail of Entrance steps. (Photo taken after a rain.) (48-1)

Preservation Treatment: The preservation methodologies for the concrete porch, walkways, and stairs are outlined in the 1985 IRI report. Prior to restoration, further investigation should be conducted in order to determine the cause of the cracks. At that time the preservation treatment could be determined. When the funds are available, the porch should be restored to its original configuration. After removing the concrete steps, the brick steps and concrete porch pattern should be reconstructed.

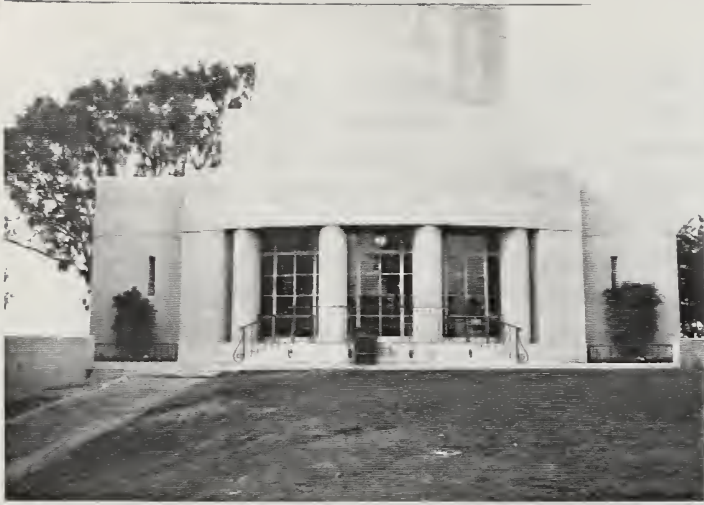
E-13. Rear South Elevation. (52-18)

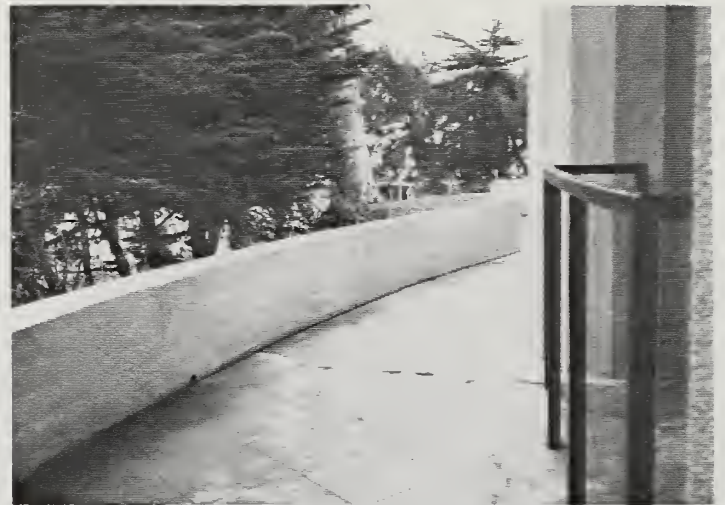
E-14. Detail of retaining wall and walkway at Rear South Porch. (50-11)

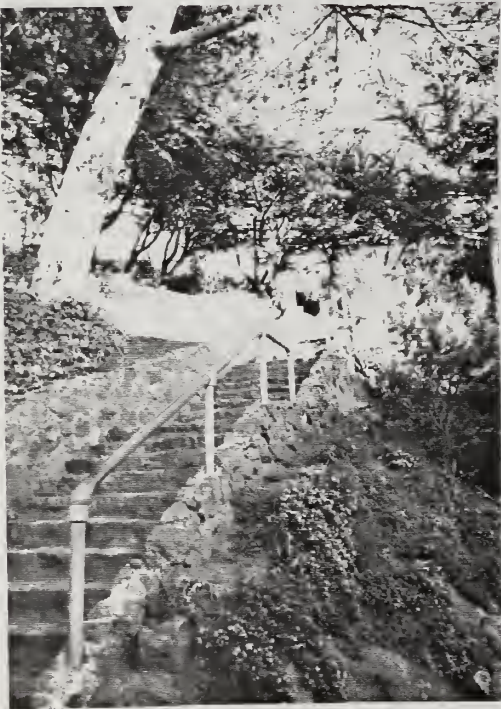
E-15. Stone steps located on the west side of Telegraph Hill. (46-22)

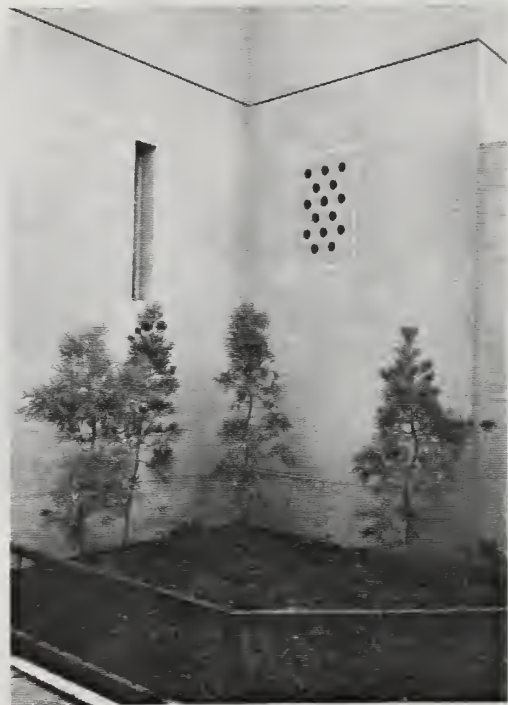
Description and Condition: The cast stone grilles have been covered with a new dash coat that appears to match the original in texture and color. The ornamental holes of the grilles have been coated in such a way that appears to effect the shape of the holes. The corners of the holes do not appear to be crisp. The seam around the grilles appears to be a caulking material. From the photographs taken prior to the restoration, there appears to be no seam. It appears the architect intended the grille to be hidden behind the dash coat. There is an apparent need for the caulking around the grille, however, an inconspicuous caulking is preferred.

E-16. Cast stone grille,
toilet window
beyond. (50-10)

Preservation Treatment: Further investigation should be conducted to find documentation as to the original appearance of the stone grilles, i.e. whether there was a seam around the grilles. When it is necessary to replace the caulking, the caulking should be replaced with a thinner strip, matching the color of the dash coat.

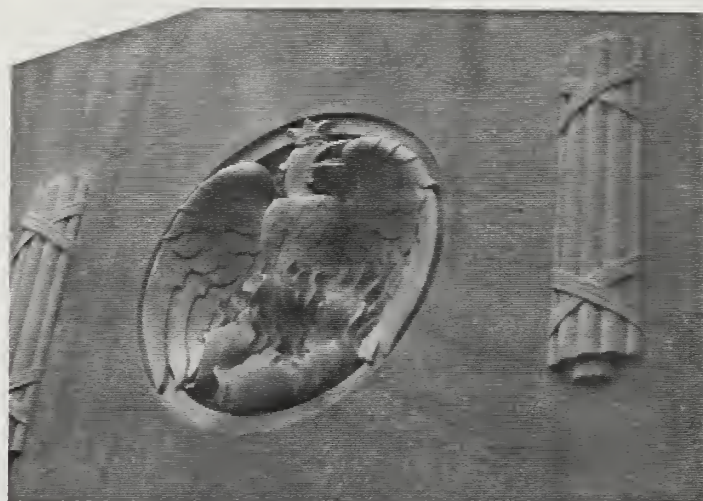
Description and Condition: The cast stone tablet of a phoenix and cast stone fasces on both sides of the tablet have been covered with a new dash coat that appears to match the original in color. The dash coat texture on the ornamentation however, appears to be rougher than the historic photos portray. It was the intention of the original architect to apply the dash coat on all of the ornaments. The original architect's specifications required "sharp well defined surfaces and arises."

E-17. Detail of Phoenix and Fasces. (75-5A)

Preservation Treatment: The ornaments should only be cleaned when necessary by a stone conservator.

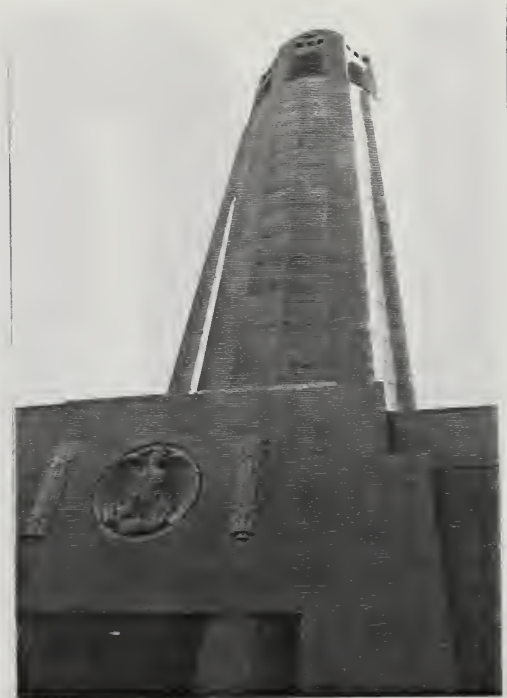
Description and Condition: The condition of the tower shaft appears to be good. The corners of the fluted shaft appear to be crisp.

E-18. Tower shaft. (85-8A)

Preservation Treatment: When the shaft shows signs of possible deterioration, it can be repaired using the same materials and methodology used on the restoration as recommended by the 1985 IRI report.

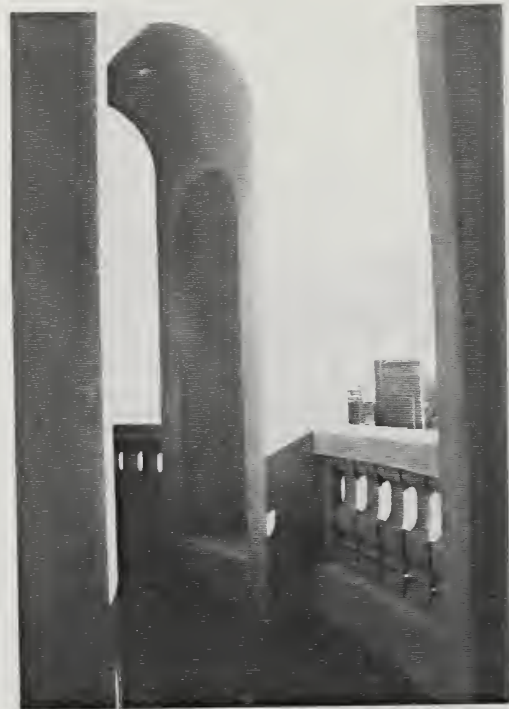
Description and Condition: The concrete features of the Belvedere level appear to be in excellent condition. The dash coat appears to be consistent in texture and color with the original dash coat. The metal light fixture/floor drains appear to be in good operating condition. The incandescent light fixtures in the arches appear to be corroded and inoperable.

E-20. View of Belvedere Level. (36-12A)

Preservation Treatment: The light fixture/floor drains should be periodically inspected in order to prevent water leakage into the tower. The incandescent fixtures should be repaired or replaced in kind only if absolutely necessary. The dash coat should be periodically maintained only when necessary by removing the stains with the gentlest methods possible. The Historical Architect recommends the use of *Sure Klean* "Defacer Eraser" or "Graffiti Control" products by the company ProSoCo, Inc. in Kansas City, Kansas described on pages IV-1 and IV-2.

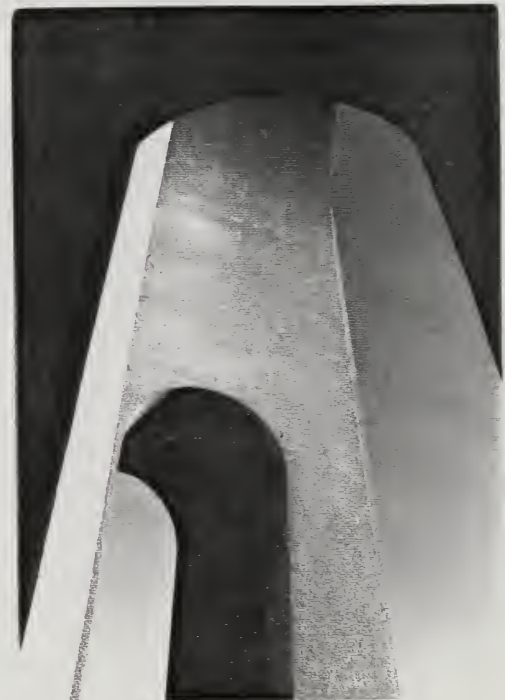
E-21. Dash coat. (88-26)

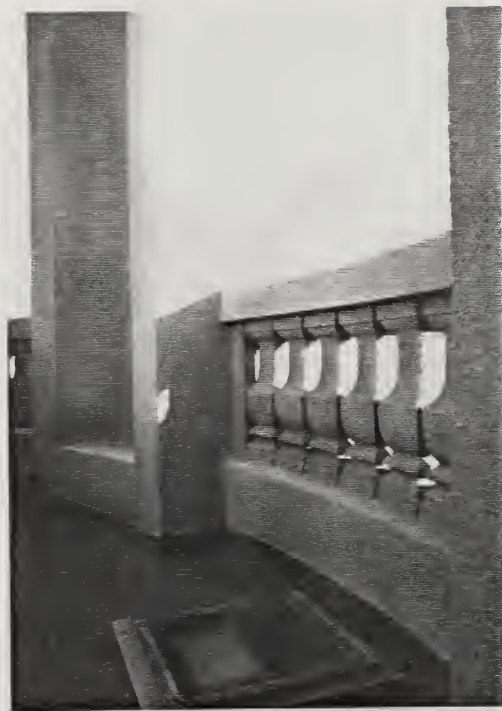
Description and Condition: According to the original architect's specifications, the balustrade sections were intended to be cast stone (p. 4-2). According to the architect's letter to the contractor dated July 22, 1933, the balusters were plain cast cement and not cast stone as specified. The balusters were replaced in 1988 with matching precast reinforced concrete units assembled on the ground and lifted into place. They were covered with a dash coat similar to the remaining structure. The balustrade presently appears to be in excellent condition.

E-22. Detail of balustrade.
(37-13A)

Preservation Treatment: The dash coat should be periodically maintained only when necessary by removing the stains with the gentlest methods possible.

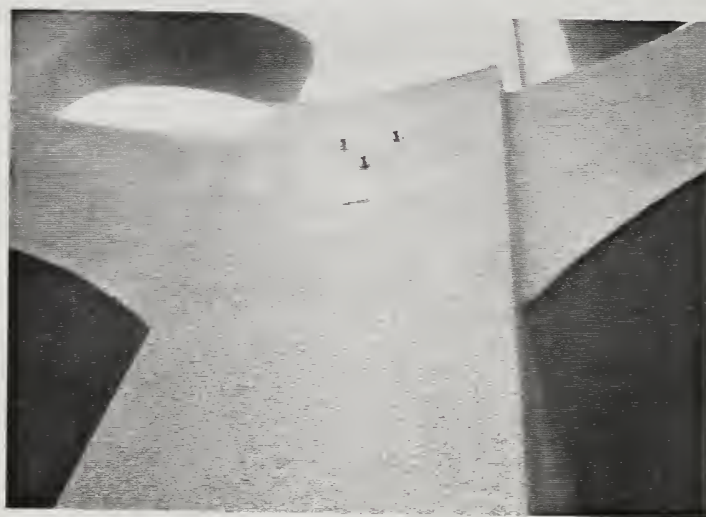
Description and Condition: The concrete features of the Roof Level appear to be in good condition. The dash coat appears to be consistent in texture and color with the original dash coat. There are stains from the scuppers. The metal cover plates where there once were light fixtures have been covered with the dash coat.

E-24. Detail. (69-24A)

Preservation Treatment: There should be investigation about the light fixtures that once were on the roof. The stains from the scuppers and atmosphere gases should be monitored and periodically cleaned.

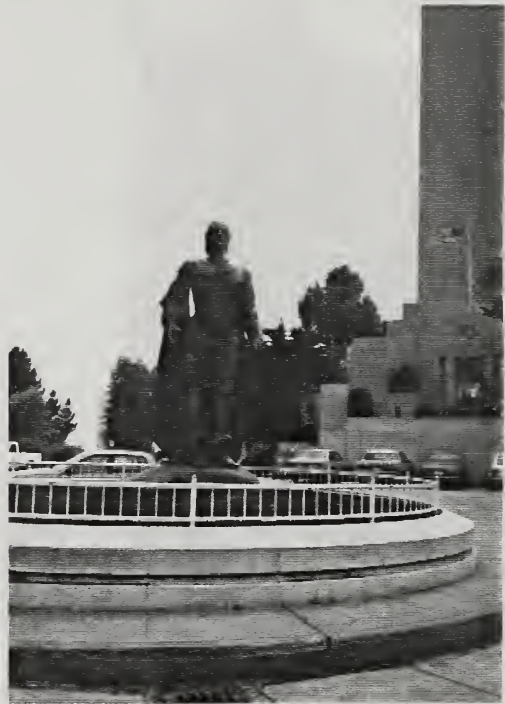
Description and Condition: Artist: Vittorio DiColbertalbo. The bronze statue of Christopher Columbus was a gift to the city by the Italian-American Society. The dedication ceremony was on Columbus Day in 1957. The statue appears to be in good condition.

E-26. Statue in front of Coit Tower. (85-6)

Preservation Treatment: The bronze statue should be cleaned by a bronze conservator.

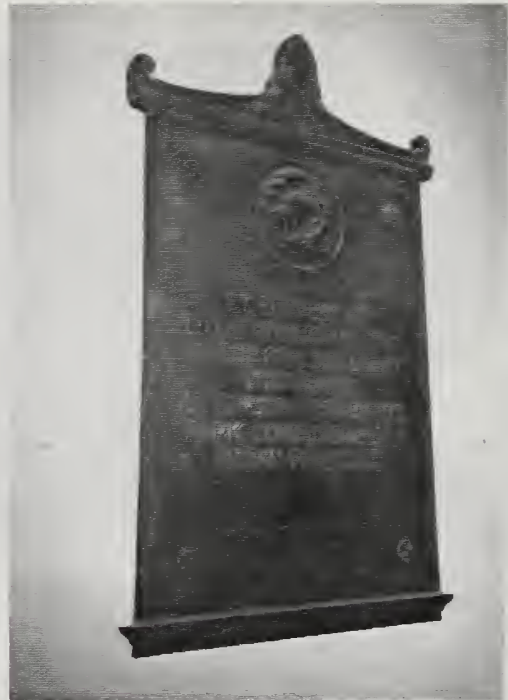
Description and Condition: The placque appears to be in good condition. April 5, 1945, Minutes of the Recreation and Park Commission state:

E-27. Bronze plaque.
(84-1)

Preservation Treatment: The bronze plaque should be cleaned by a bronze conservator.

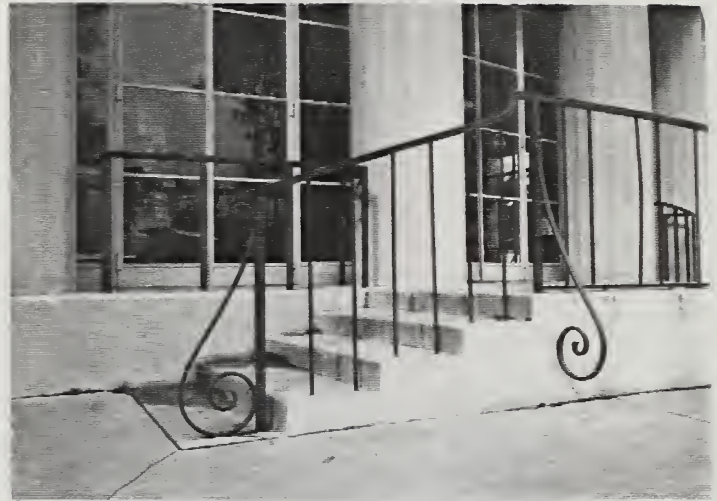
Description and Condition: The exterior iron railings have many coats of paint. The detailing and sharp edges have been lost due to the many layers. Otherwise they appear to be in good condition. According to Arthur Brown Jr.'s specifications, the exterior rails were intended to be galvanized iron work, primed, and finished "with four coats of aluminum paint." Therefore, the original color for the exterior rails was aluminum (an aluminum color--silver).

E-28. Railing at Rear
South Porch. (50-12)

Preservation Treatment: According to the architect Arthur Brown, Jr. drawings and specifications, the railings were to be ". . . galvanized, . . . cleaned off, smoothed down, left free from all roughness and finished with an even color." The existing paint should be removed, primed, and replaced with four coats of aluminum paint.

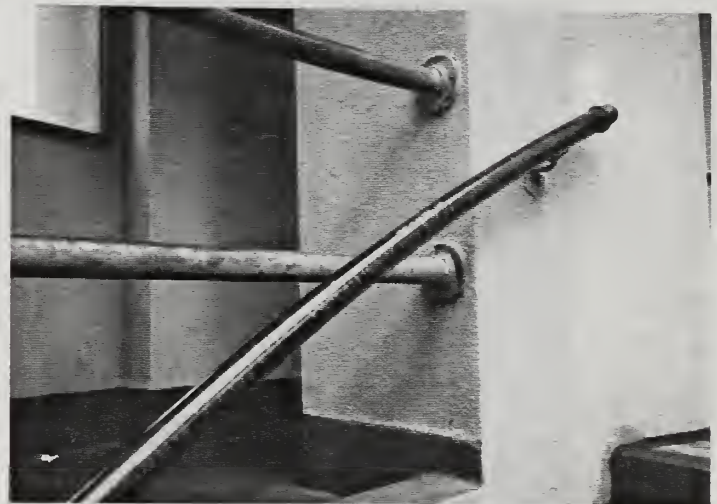
E-29. Railing at Lantern
Level. (69-23A)

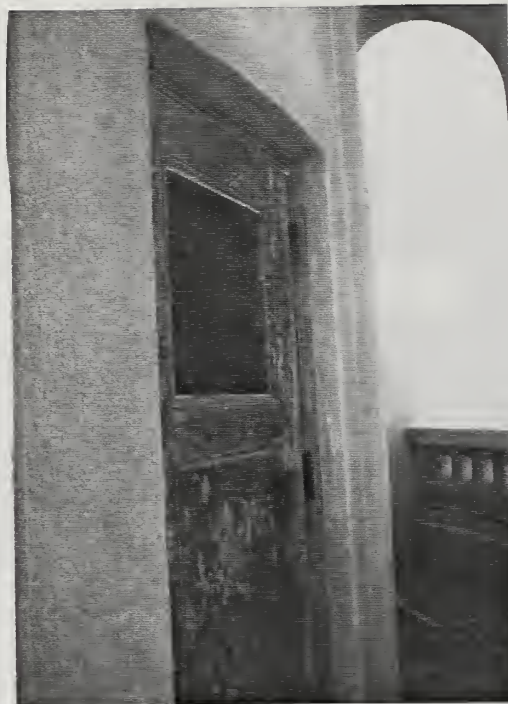
Description and Condition: According to the architect Arthur Brown, Jr.'s specifications, five doors and casings were "Kalamein" doors. These doors are constructed of wood with copper coverings that are coated with a clear lacquer. The door for the Machine Room with an air vent, is metal covered on the back and the inner trim is metal covered. According to the specifications, the thresholds are extruded or cast bronze. The hardware is bronze.

E-30. Belvedere Level. (38-17)

Preservation Treatment: After sufficiently testing the doors, the copper should be cleaned with an appropriate chemical method avoiding abrasive methods and finished with a clear coating to match the original transparent lacquer finish. See pp. 19 - 21, Sec. of Interior Guidelines and Preservation Brief #4 (under "Metal").

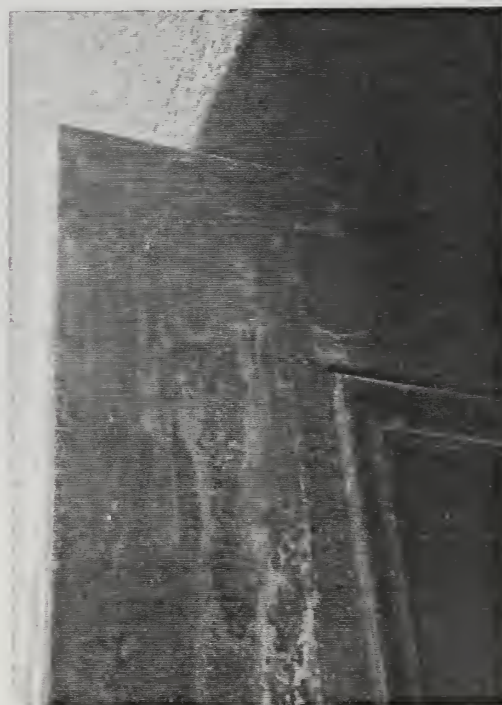
E-31. Detail of door. (58-12)

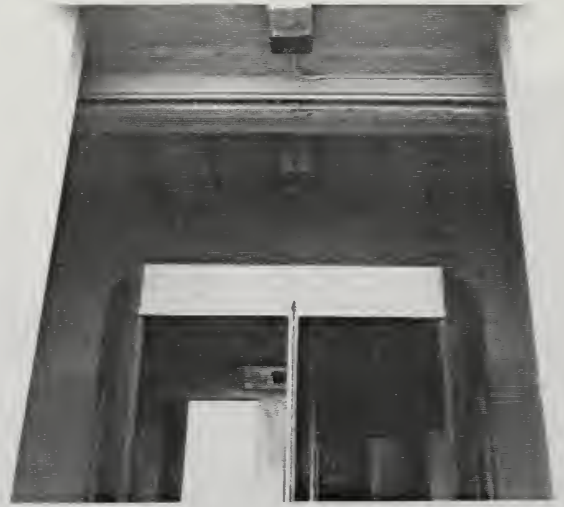
Description and Condition: This light fixture is basically unseen due to the revolving door. It is historically significant because it is a fine example of the "Art Deco" style that was prevalent in this country at the time of the construction of Coit Tower.

E-32. Ornament above
revolving door.
(74-1A)

Preservation Treatment: The wiring for the historic hanging light fixtures should be checked and the fixtures cleaned to remove corrosion by a professional in historic light fixtures, such as Nowell's Victorian Lighting (415/332-4933). See pp. 19 - 21, Sec. of Interior Guidelines.

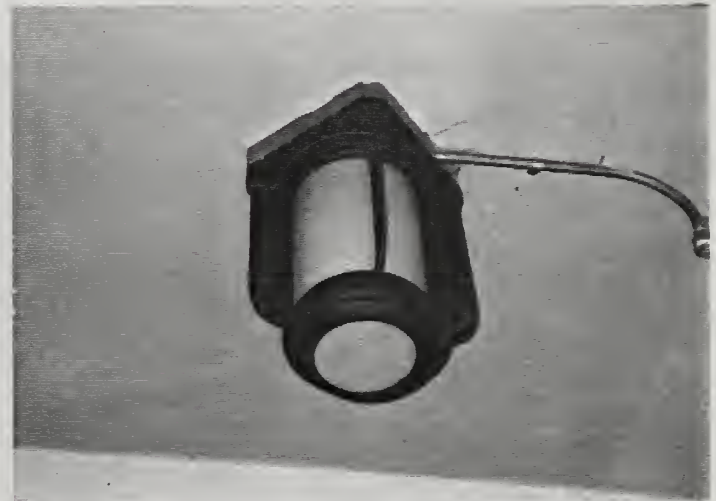
E-33. Detail of ornamental
light fixture (83-00)

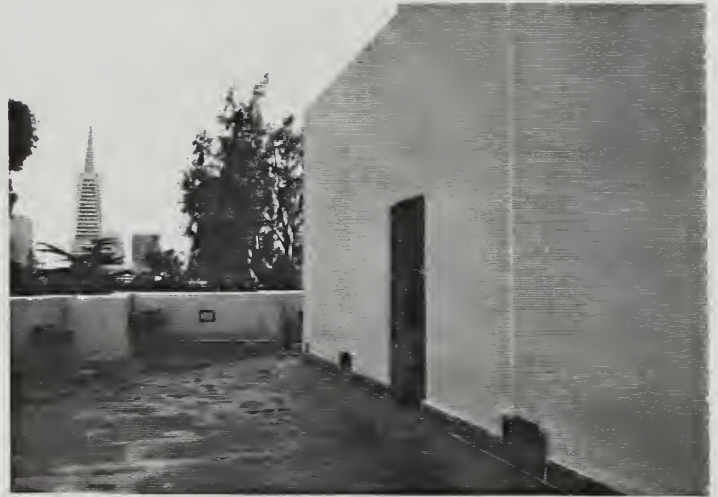
Description and Condition: According to the Arthur Brown, Jr.'s drawings and specifications, the original roof covering was quarry tile bedded in concrete over a split slab construction. The new flooring is smooth elastomeric membrane over insulation over the structural slab. Before the 1988 restoration, the roof was covered with a three-ply asphalt and gravel built-up roof. The ballast, membrane, and tile were removed during restoration and replaced with new elastomeric membrane in a color perhaps similar to the original quarry tile. The elastomeric was installed over insulation therefore minimizing the removal process when the original quarry tile is reinstalled.

E-34. View of roof over galleries. (61-23)

Preservation Treatment: The roof should be monitored for any signs of deterioration or leakage. The manufacturers for the "Dex-O-Tex Weatherwear" roof covering recommend after a period of weathering or traffic (generally several years) apply roller coat of surface dressing. The roof drains should be monitored and repaired when necessary. When funds are available, the quarry tile should be reinstalled over a waterproof membrane. The original quarry tiles were not installed adequately to prevent water from penetrating through to the structure. When the Base Level deck is open to the public, the wood decking in the Keepers Area should be removed.

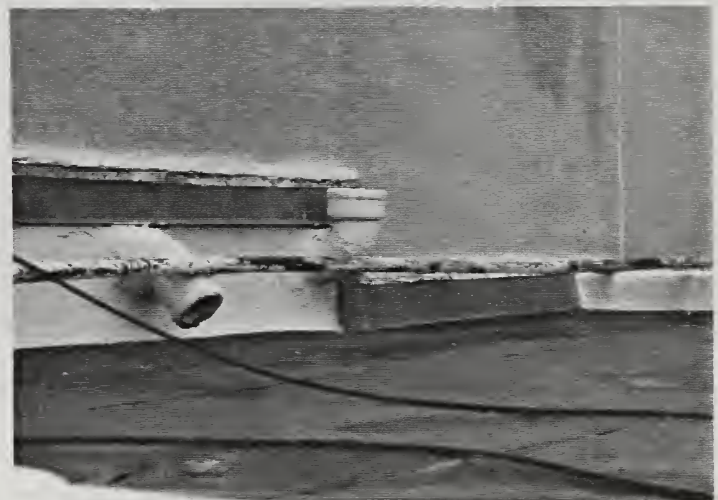
E-35. Detail of flashing and miscellaneous pipes. (60-20)

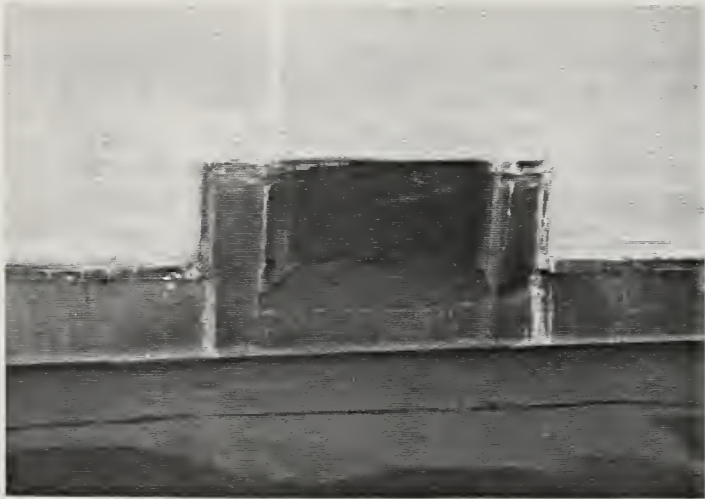
E-36. Detail of flashing. (60-17)

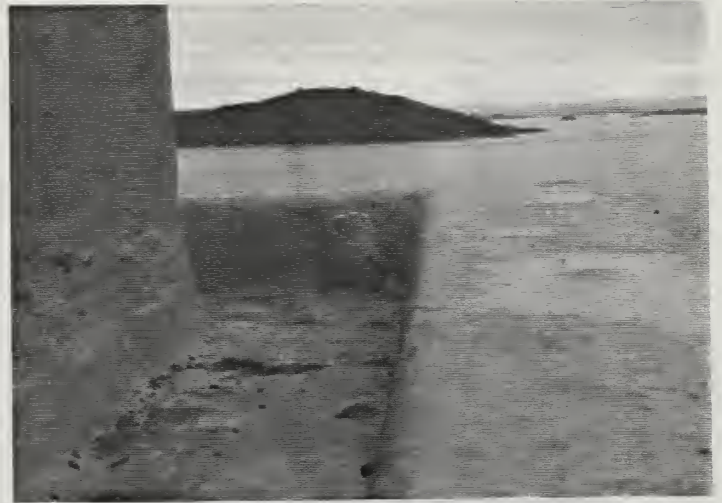
E-38. Roof over front entrance door. (60-19)

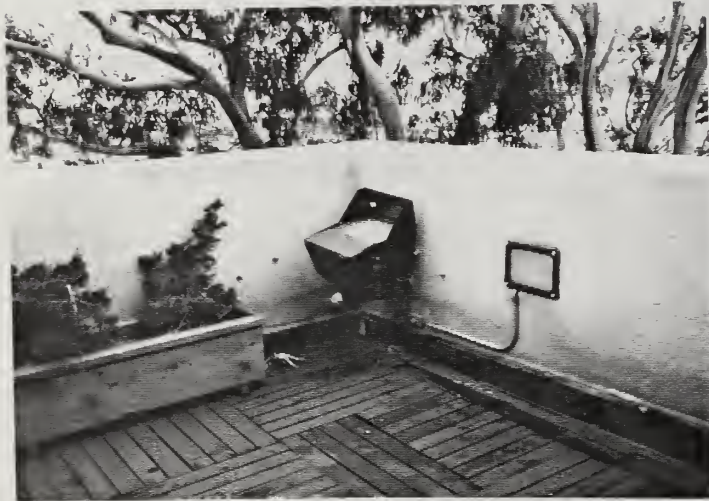
E-37. Wood decking on roof near Keeper's Apartment. (64-2A)

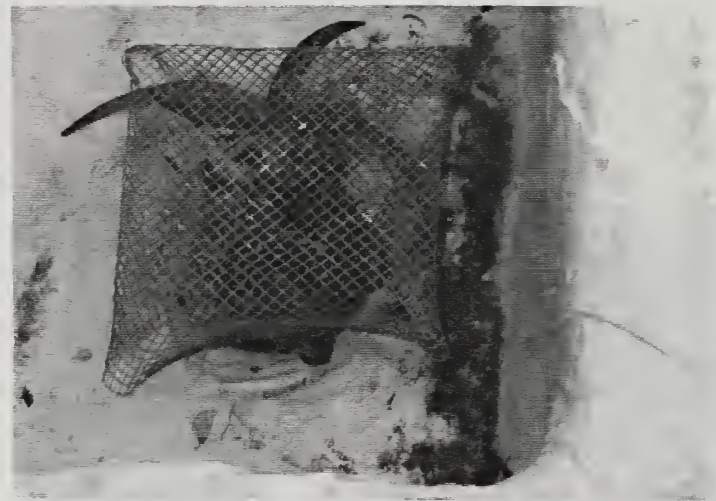
E-39. Roof drain on roof over entrance door. (61-21)

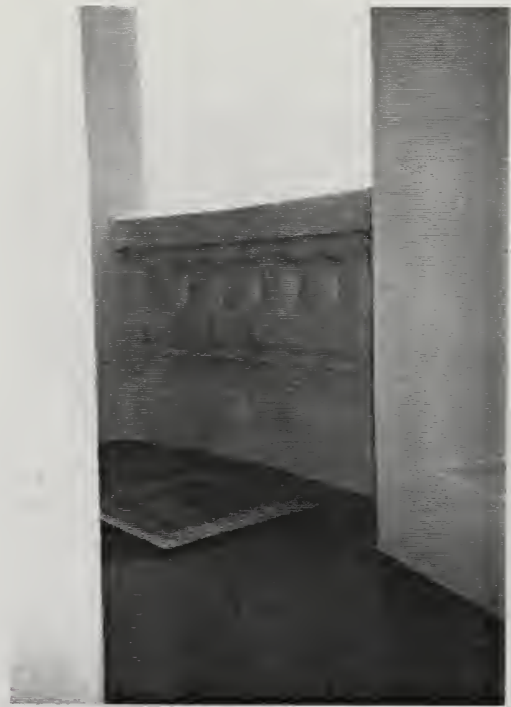
Description and Condition: The new flooring is smooth elastomeric membrane similar to the new roofing material for the Base Level roof. According to the architect Arthur Brown, Jr.'s drawings, the original floor material was a quarry tile, similar to the quarry tile used on the other roof surfaces. At some point the quarry tile was covered with a membrane material. A new elastomeric membrane was installed over the existing tile and membrane during restoration, in the same color as the previous membrane.

E-40. Belvedere Level roof. (66-11A)

Preservation Treatment: The roof and the roof drain/light fixtures should be monitored for any signs of deterioration or leakage. When funds are available, the quarry tile should be reinstalled over a waterproof membrane. The original quarry tiles were not installed adequately to prevent water from penetrating through to the structure.

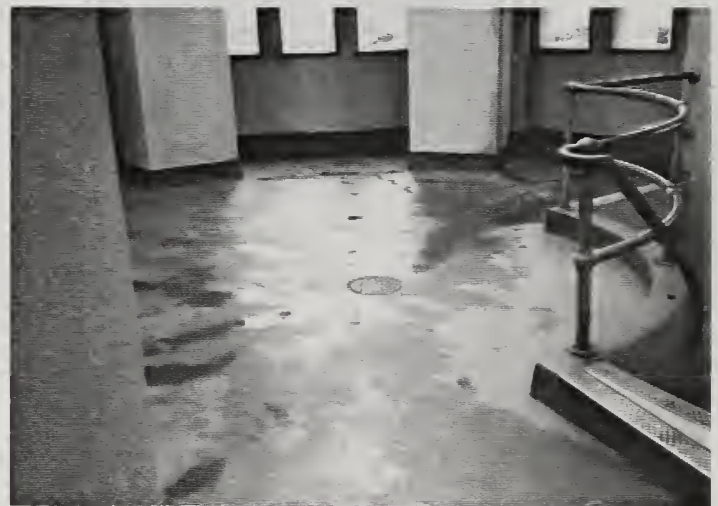
E-41. Roof at Lantern Level after rain. (70-27A)

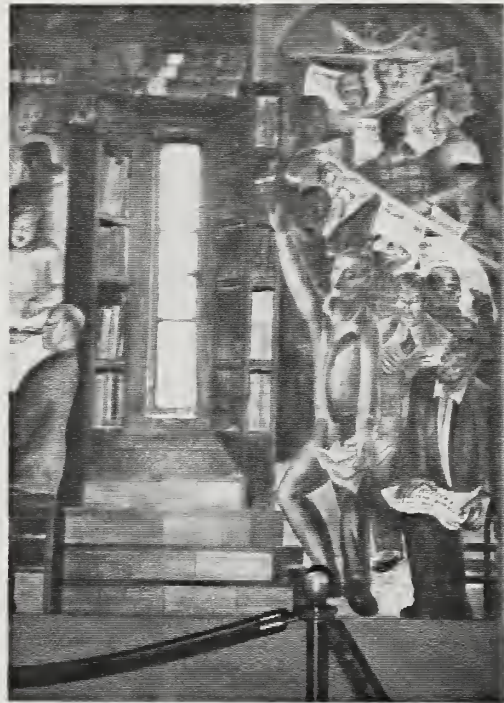
Description and Condition: The narrow steel casement windows in the gallery have primary historical significance and should be preserved. They are 9 inches wide and 4 feet in height and have heavy "statuary bronze" finished hardware. According to Arthur Brown, Jr.'s specifications, all metal sash and frames, were to be primed and have four coats of aluminum paint. The windows appear to be in fair condition with many areas of rust. When the casement windows broke, they were replaced with wire glass.

E-43. Gallery window. (78-18A)

Preservation Treatment: The steel windows should be thoroughly cleaned, the paint and rust removed, exposed metal primed with rust inhibiting primer, missing screws or fasteners replaced, the hinges cleaned and lubricated, then repaint the steel sections with four coats of aluminum paint. The steel windows should be tested before removing the rust with chemicals. A test should be conducted to determine the original color and content of paint. A preliminary color test was conducted and concluded that the original color may have been an aluminum color. A thorough explanation of the cleaning of metal windows is found in the Preservation Brief #13. The replacement of the clear glass with wire glass decreases the historical integrity of the building. The wire glass should be replaced with clear laminated glass.

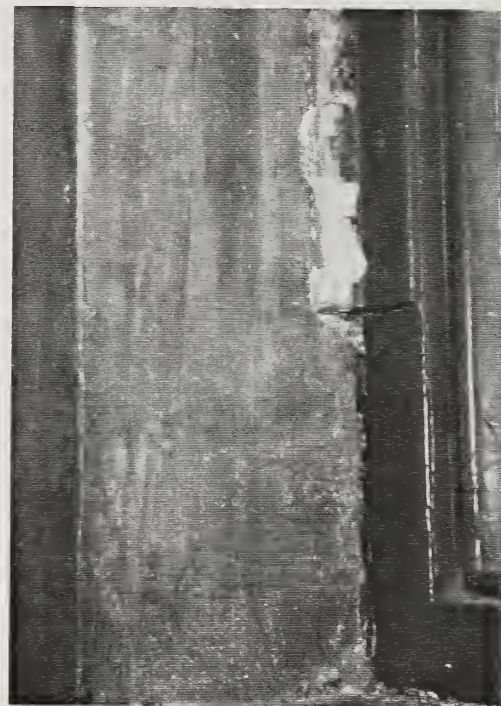
E-44. Detail of sash. (77-15A)

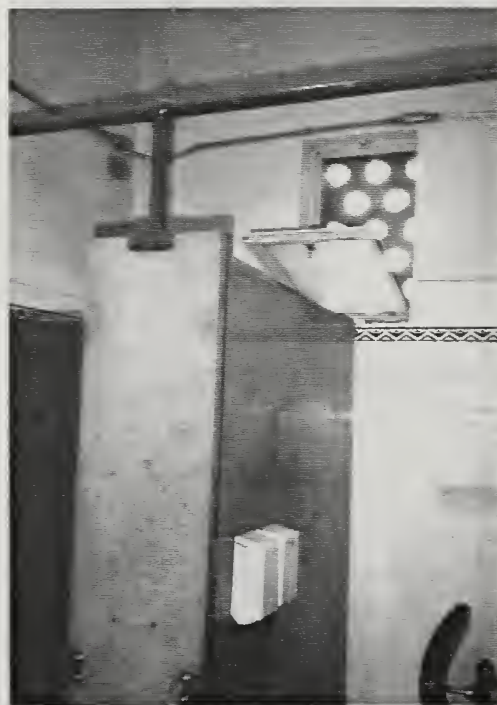
Description and Condition: The toilet room, tower shaft, and Keeper's room steel windows are secondary. Since they are not readily seen by the viewer, their historic importance is minimal. The toilet room windows are painted and in good condition. There is one window in both Men's and Women's toilet room. They are 1 foot 6 inches wide and 2 foot 6 inches high. They are hinged at the bottom and have a bronze catch on the top. There are cast stone grilles beyond each window. The narrow steel windows in the tower shaft are 6-3/4 inches wide and 3 feet high. The closure hardware is on the top, and they are hinged on the bottom. The Keeper's room windows have been altered.

E-45. Toilet Room. (81-29A)

Preservation Treatment: The steel windows should be thoroughly cleaned, the paint and rust removed, exposed metal primed with rust inhibiting primer, missing screws or fasteners replaced, the hinges cleaned and lubricated, then repaint the steel sections with four coats of aluminum paint. When the public is allowed on the base level roof deck, the windows of the Keeper's apartment should be restored or redesigned to a more appropriate configuration. A thorough explanation of the cleaning of metal windows is found in the Preservation Brief #13. See pp. 25 and 26, Sec. of Interior Guidelines, and Preservation Brief #13.

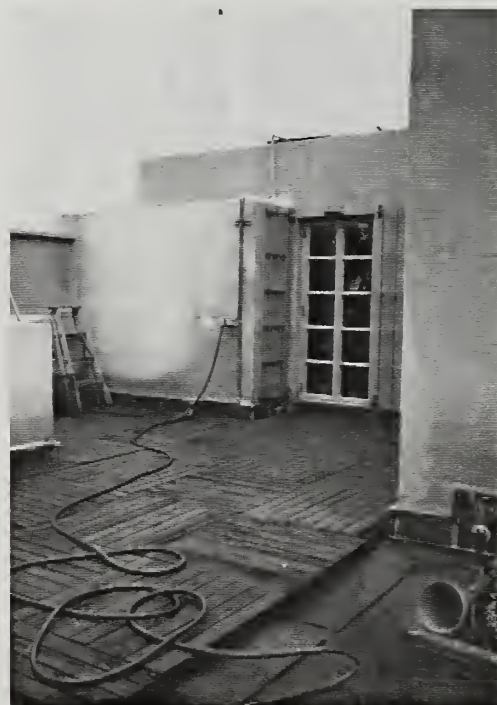
E-46. Keeper's area. (62-24)

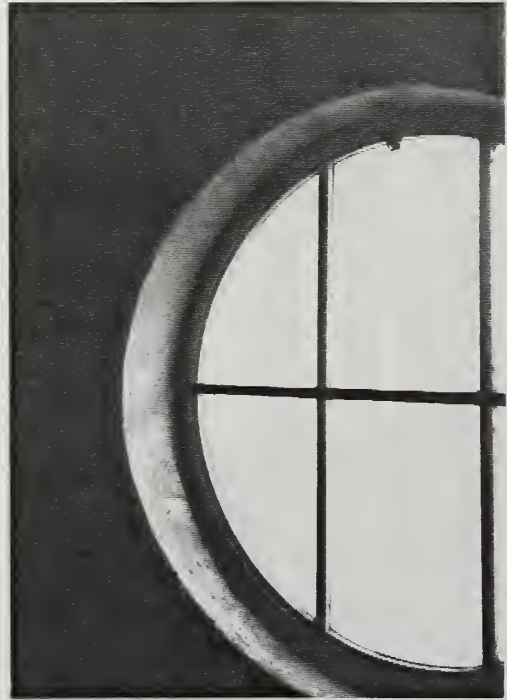
Description and Condition: The Belvedere level has one round steel window, 3 foot 6 inches in diameter. It is divided in the middle with three panes on the top and three panes on the bottom. The window opens from the top with a bronze catch and is hinged in the middle. It has many layers of paint. The other Belvedere windows are three fixed windows, 1 foot 6 inches wide and 2 foot 6 inches high. These windows appear to be severely rusted.

E-47. Belvedere Level.(71-31A)

Preservation Treatment: The steel windows should be thoroughly cleaned, the paint and rust removed, exposed metal primed with rust inhibiting primer, missing screws or fasteners replaced, the hinges cleaned and lubricated, then repaint the steel sections with four coats of aluminum paint. The steel windows should be tested before removing the rust with chemicals. A thorough explanation of the cleaning of metal windows is found in the Preservation Brief #13. At this time, the purpose is unknown for the rusted safety bars installed over the dash coat. The bars should be removed and a safety measure should be redesigned. See pp. 25 and 26, Sec. of Interior Guidelines, and Preservation Brief #13.

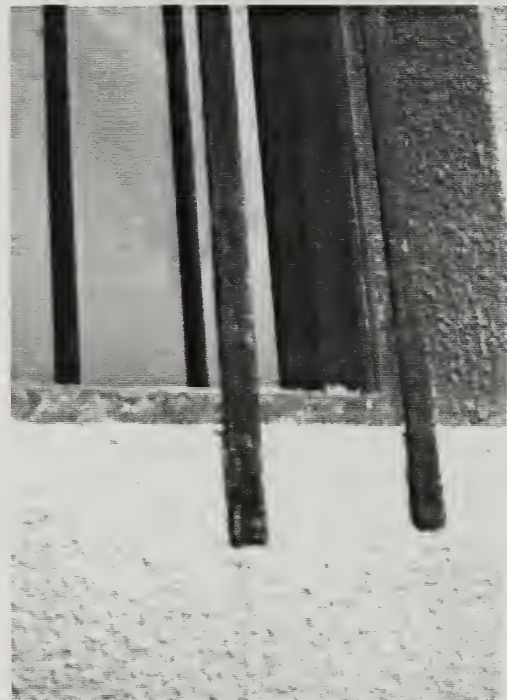
E-48. Rusted metal bars.(67-14A)

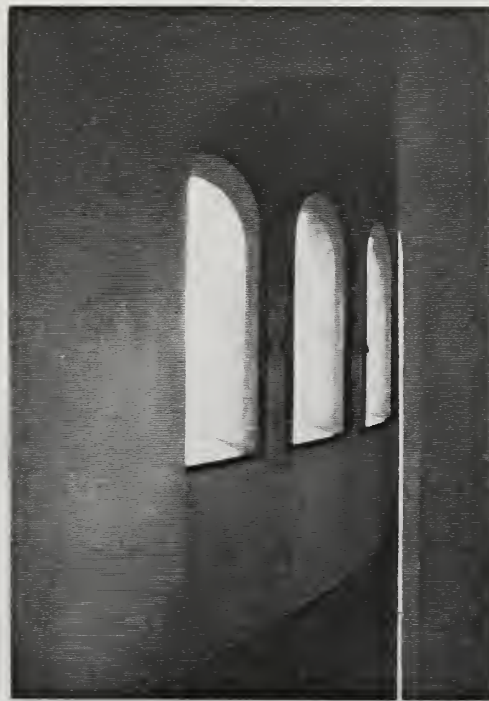
Description and Condition: The metal frame fixed windows on the Roof Level are not original. They were added in 1981 to prevent people from falling through. The plastic glass is scratched but otherwise in good condition.

E-49. Metal fixed windows, Lantern Level. (89-34)

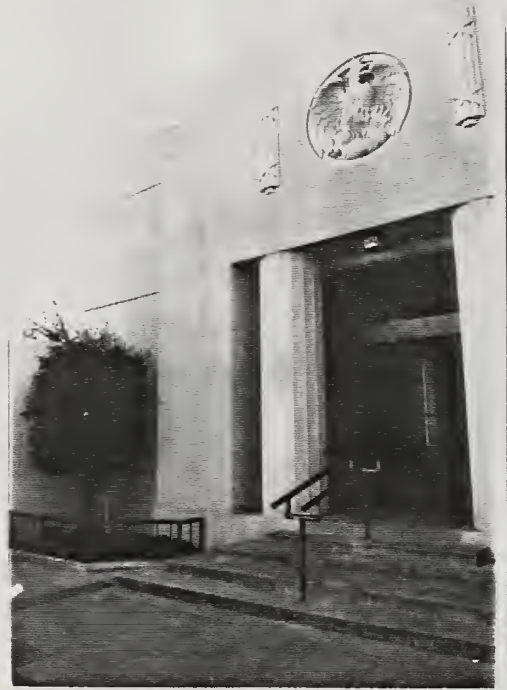
Description and Condition: There presently is a revolving door that replaced the original double doors. At this time, it is unknown when the front doors were removed. The revolving doors protrude out into the front porch and have been fixed in place. The brick steps had to be replaced with a concrete platform to hold the revolving door, and new concrete steps were constructed out onto the concrete porch. The revolving doors hide the dedication plaque of Lillie Coit on the wall left of the doors.

E-50. Entrance alterations. (85-8)

Preservation Treatment: The revolving doors should be removed. The original brick stairs, sunken mat, and entrance doors should be reconstructed according to the Arthur Brown Jr.'s architectural drawings and specifications. It was intended to paint the front doors two colors, one color for the stiles and rails, one color for the panels and molds. The paint for the doors was to be opaque and finished flat.

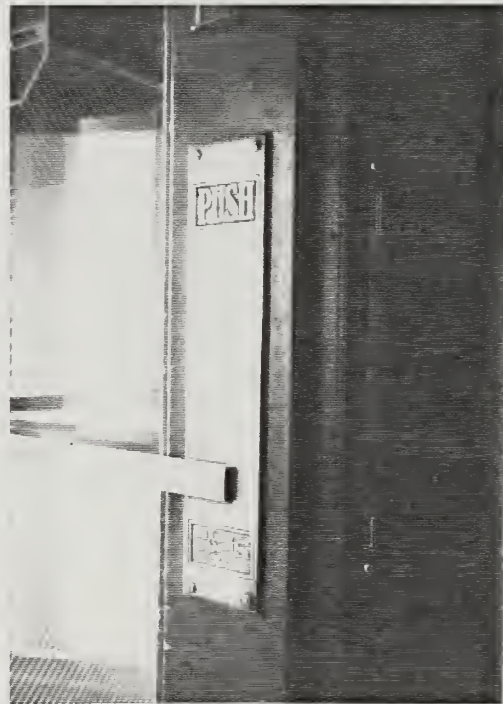
E-51. Detail of handle. (75-7A)

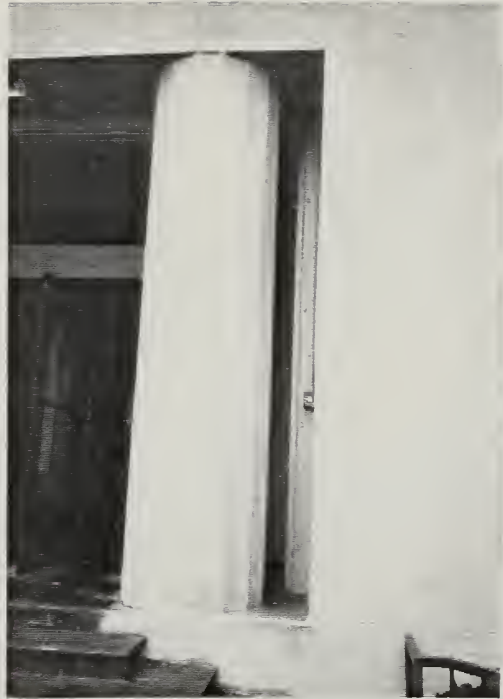
Description and Condition: The fluted columns are historically significant features of the building and should be preserved. They are presently in excellent condition.

E-53. Detail of fluted column at Front Entrance. (75-6A)

Preservation Treatment: The columns should be preserved and cleaned only when absolutely necessary with method similar to the base walls. See pp. 28 and 29, Sec. of Interior Guidelines.

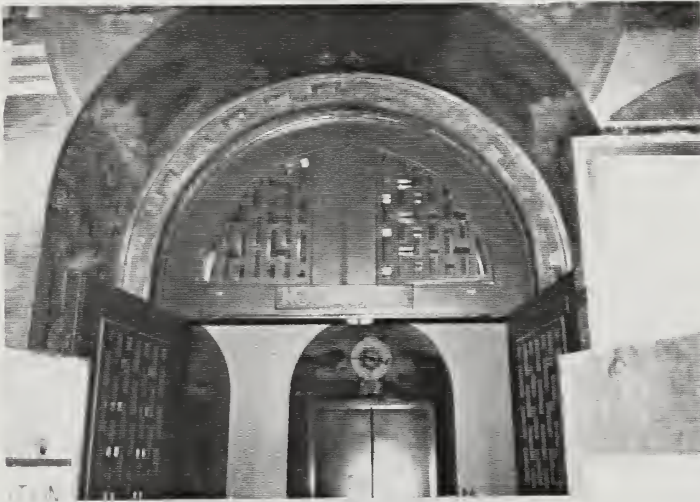
I-1. Grille doors. (During fresco restoration)
(76-10A)

MATERIAL/TYPE	CONDITION	COMMENTS/RECOMMENDED TREATMENT
FLOOR	12" x 6" quarry tile	good	Clean. Remove heavy wax build-up.
BASE	6" quarry tile	good	Clean.
WALL	frescos painted plaster	excellent fair	Frescos cleaned by conservator only. Clean plaster with gentlest method possible or repaint with paint formulated to match original color and finish.
CEILING	concrete	fair	Remove paint to smooth surface and repaint in original wheat color with terra cotta border. Conservators should protect murals during the repainting of adjacent surfaces.
DOORS	wood grille	good	Glass panes inside operable grille panels. Double doors painted with many coats of brown paint that appear to effect the details and sharp corners of the grille. Clean Hardware. Strip to less than 4 mil and paint original dark aqua green color.

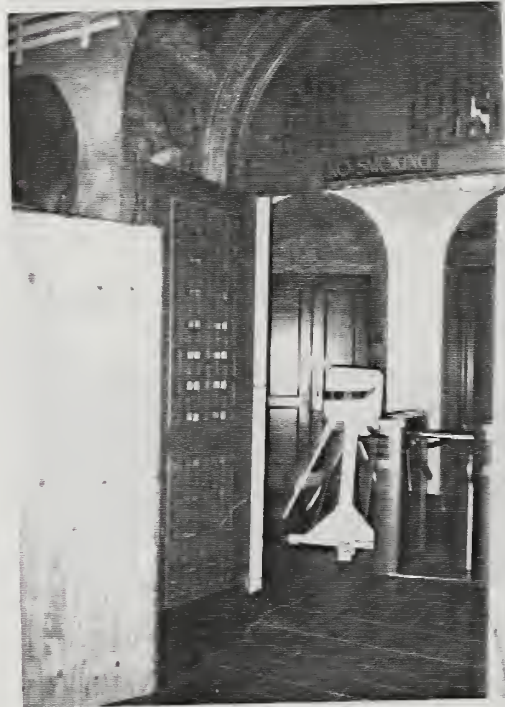
I-2. Grille doors. (76-9A)

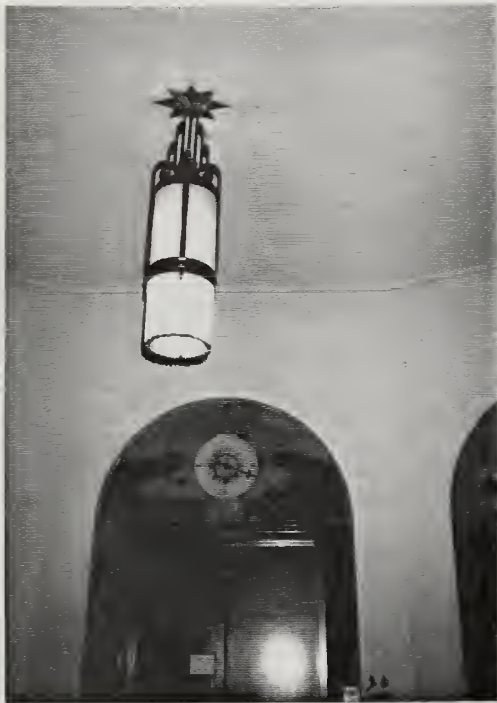
I-3. Ornamental light fixture. (56-02)

MATERIAL/TYPE	CONDITION	COMMENTS/RECOMMENDED TREATMENT
FLOOR	12" x 6" quarry tile cement border	good	Clean. Remove heavy wax build-up.
BASE	6" quarry tile	good	Clean.
WALL	paintings on canvas painted plaster	excellent good	Paintings cleaned by conservator only. Clean or repaint walls with paint formulated to match original color and finish.
CEILING	acoustical ceiling tiles	fair	Remove acoustical ceiling. Clean and repair. Repaint to original color.
DOORS	solid wood double doors,	good	Arthur Brown, Jr. drawings indicate original intention to have wood grille doors in the elevator lobby. Presently, there are double solid wood doors to stairs, one metal elevator door, and solid double doors to gift shop. Clean hardware. Repaint original door color.
FIXTURES	metal ceiling hung	good	Excellent example of style "Art Deco." Wiring for hanging fixtures should be checked and fixtures cleaned to remove corrosion by a professional in historic light fixtures, such as Nowell's Victorian Lighting (415/332-4933).

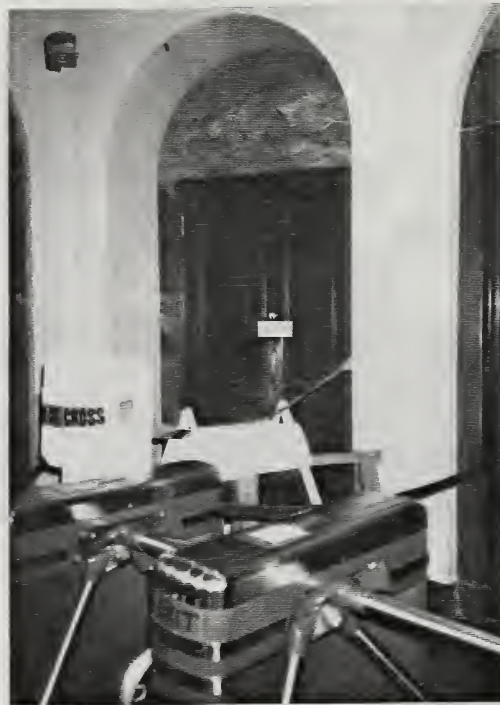
I-4. Door to stair, turnstiles.(56-01)

OTHER	turnstiles	fair	Replace with more appropriate system compatible to the historic integrity of the building.

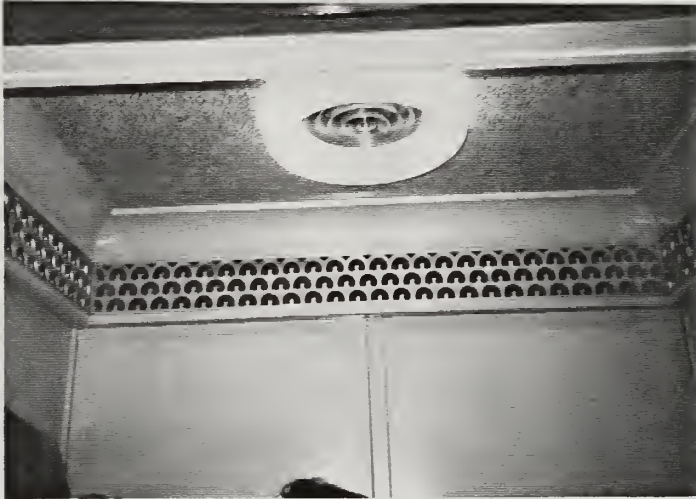
I-5. Ceiling of elevator. (84-04)

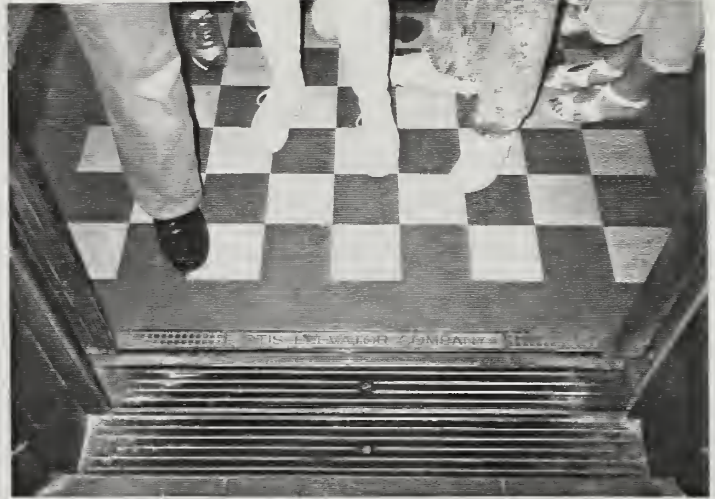
I-6. Elevator floor displaying the Otis name. (85-05)

MATERIAL/TYPE	CONDITION	COMMENTS/RECOMMENDED TREATMENT
FLOOR	linoleum tile 6" x 6"	fair	Remove tile and restore original floor material.
BASE	wood		Clean.
WALL	metal grey gloss paint	good	Clean.
CEILING	acoustical tile		Clean.
DOORS	metal		Clean.
FIXTURES	new fluorescent circular tube	fair	
OTHER	metal grille	good	Strip old paint if over 15 mils thick. Repaint with original color.
